Inspection Methods for Characterizing Subsurface Impact Damage in Solid Laminate Aerospace Composites

**Stephen Neidigk, Dennis Roach,
Tom Rice, Randy Duvall
FAA Airworthiness Assurance Center
Sandia National Labs**

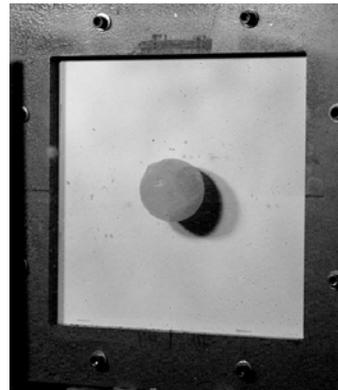
Ice Impact Damage on Laminate Plates

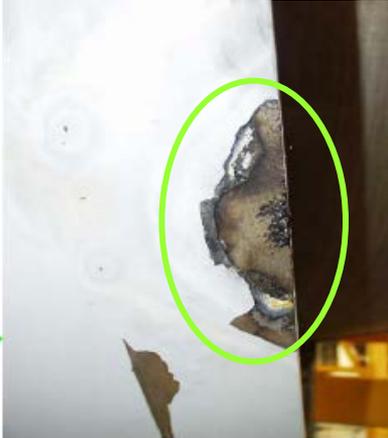
Lightning Strike on Thrust Reverser

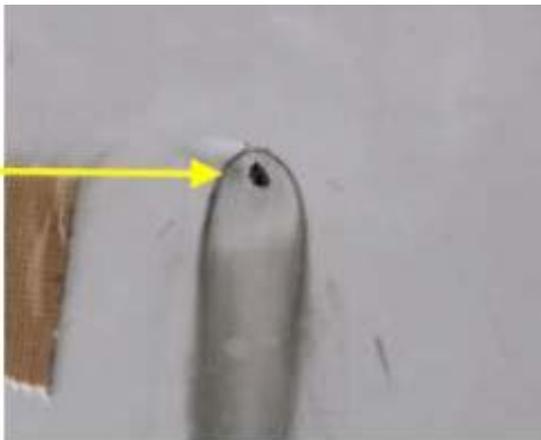
Lightning Strike on Fuselage

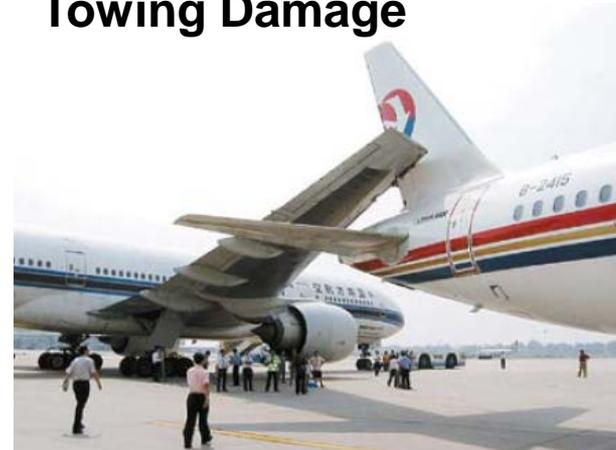
Inspection Challenge – Hidden Impact Damage

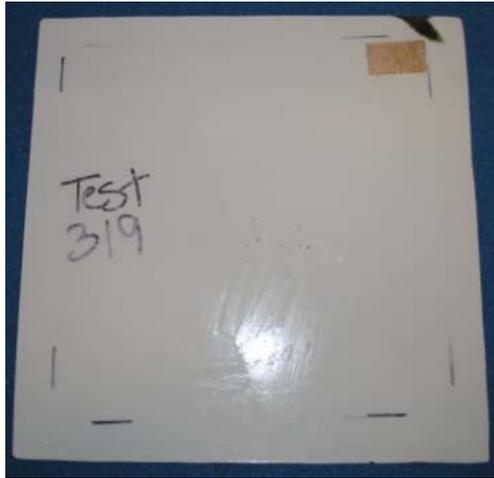
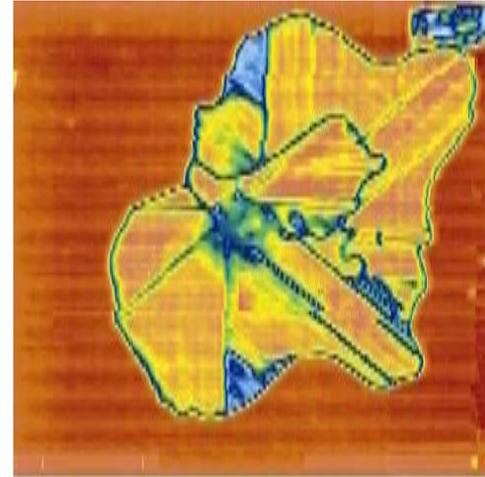
Damage from ground vehicle

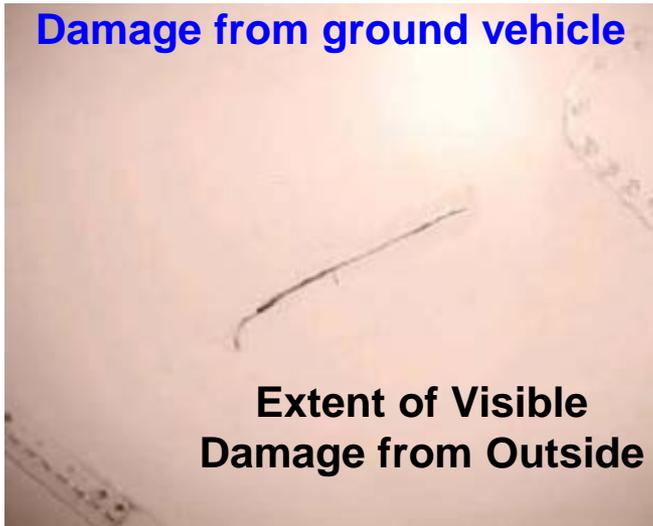
Extent of Visible
Damage from Outside

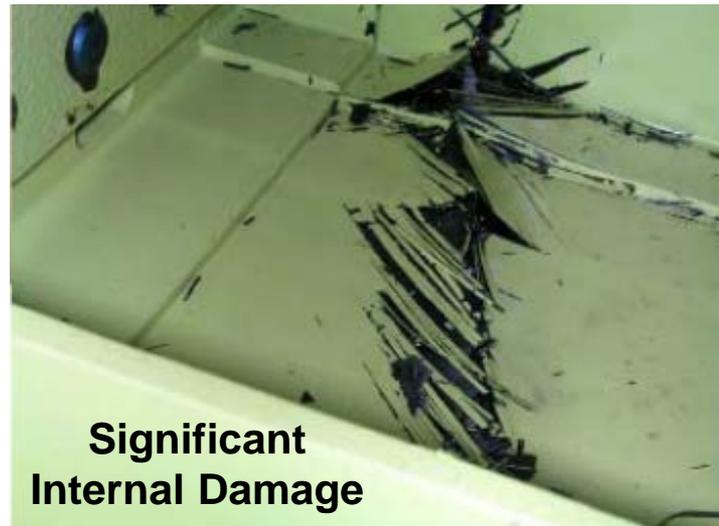
Significant
Internal Damage

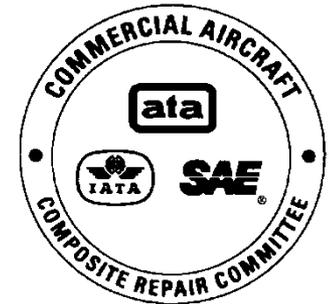
*Inspection
Task Group*

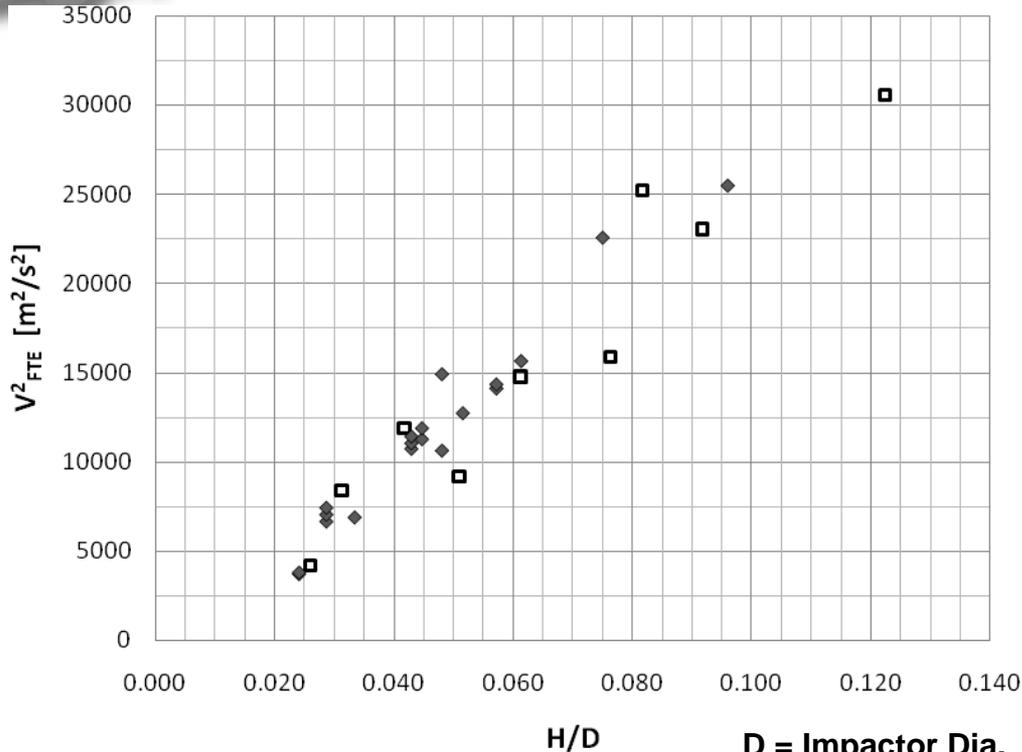
□ T800/3900-2 Tape (Current Data)

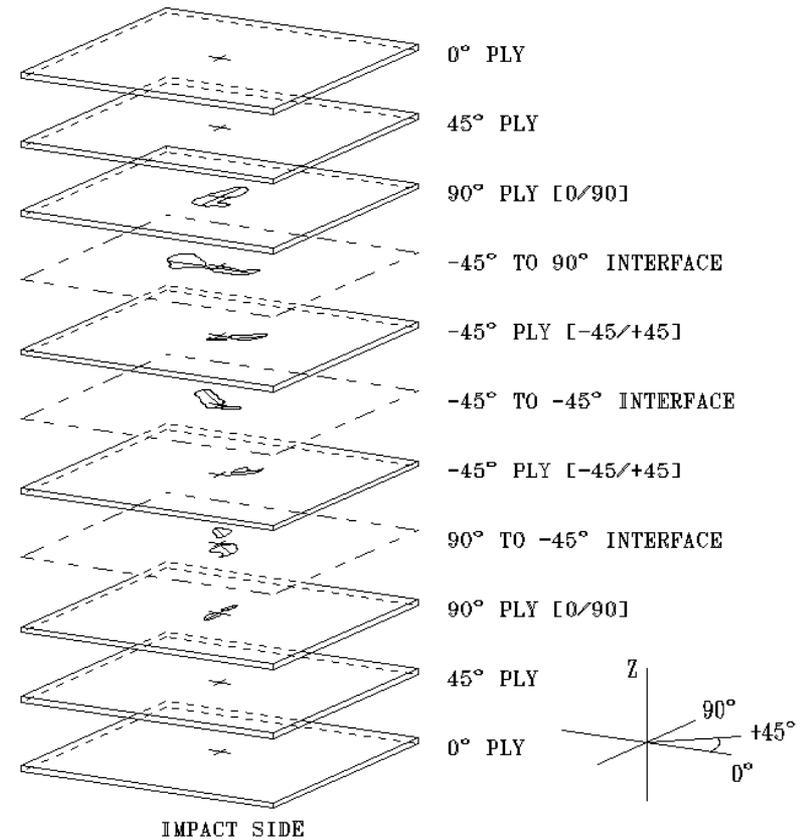
Impact-Induced Damage Morphology for 8 Ply Panel; 42.7 mm Ice at 120.4 m/s (267 J)

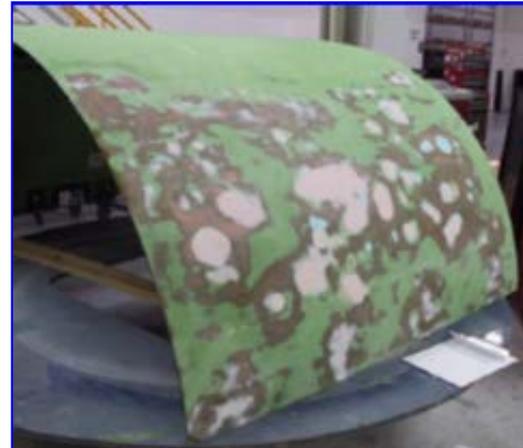
Composite Impact Damage – Inspection Methods Deployed

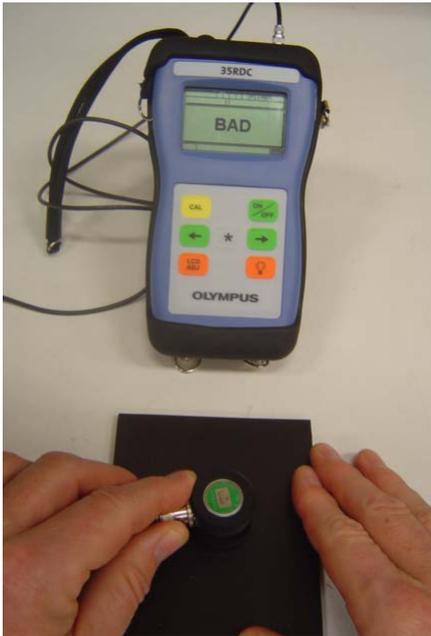
**Damage Check Device
(Pulse-Echo UT)**

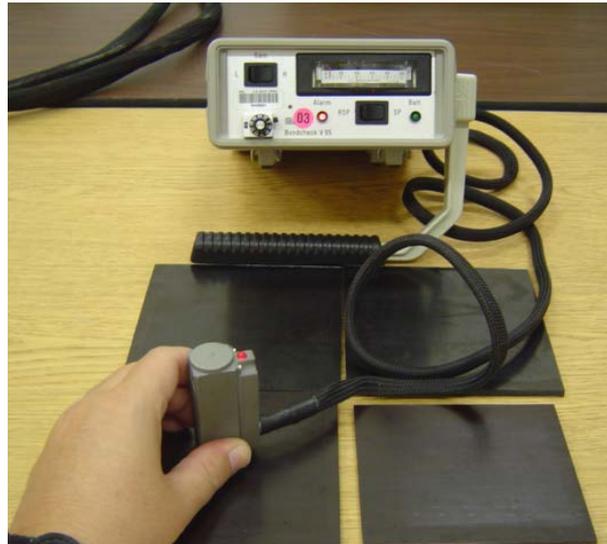
**V-95
(Mechanical Impedance
Analysis)**

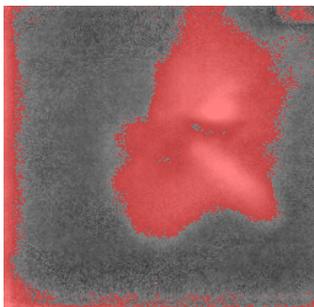
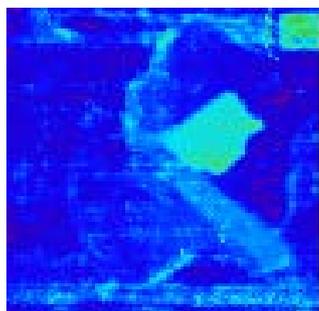
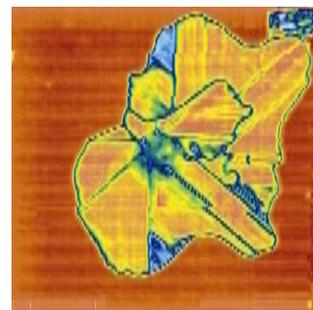
Ramp Damage Checker
(flaw indicated)

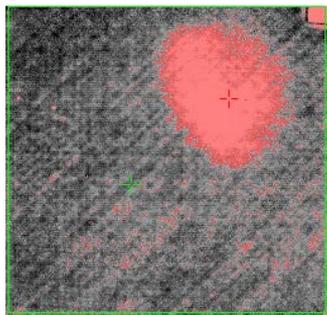
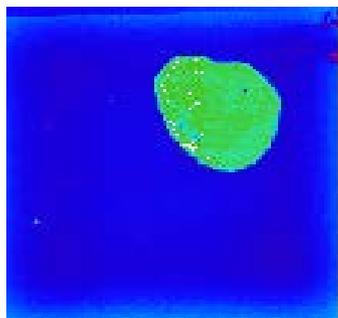
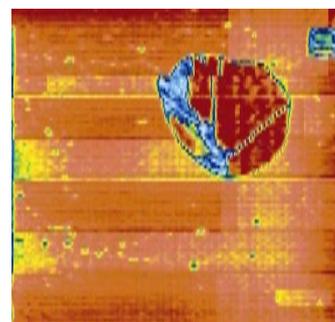
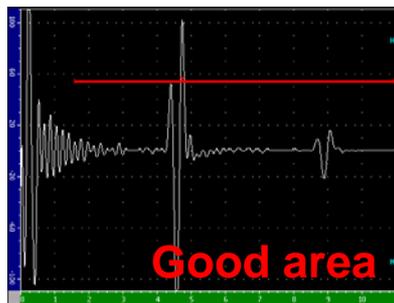
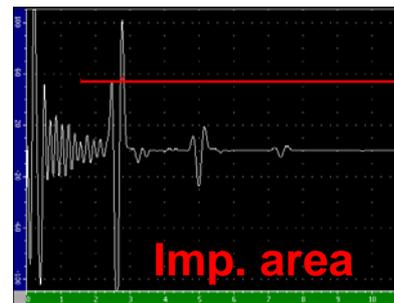
FAA William J. Hughes
Technical Center

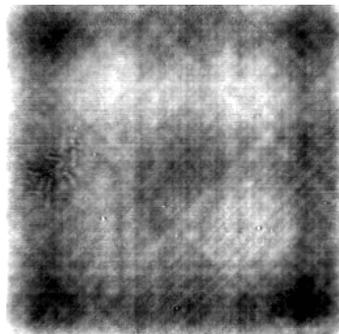
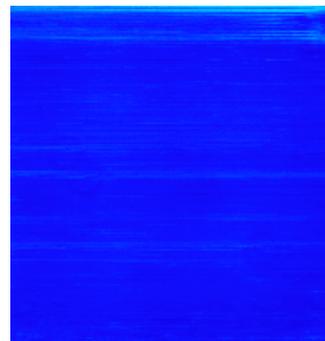
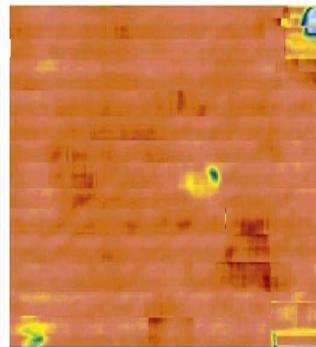
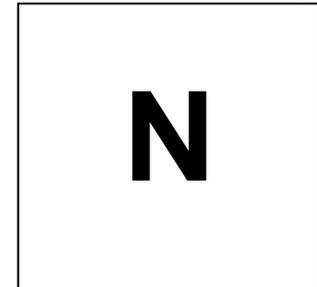
**Ramp Damage Checker
(flaw indicated)**

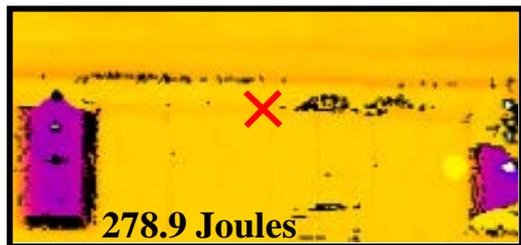
Stringer Flange Impacts

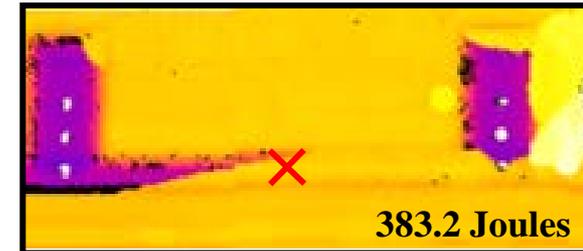
- Induce only substructure flange disbonding
- No damage was visually detectable from the surface
- Damage was initiated at approximately 170 Joules (~56 m/s)

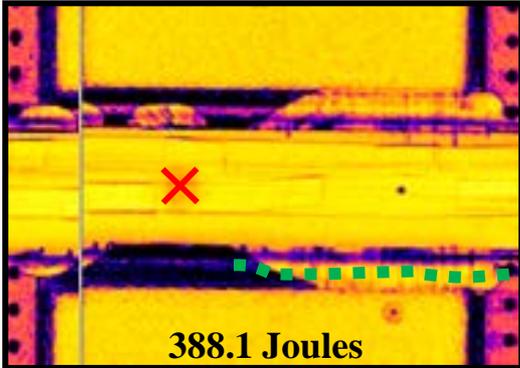
Ice Impact Testing Results

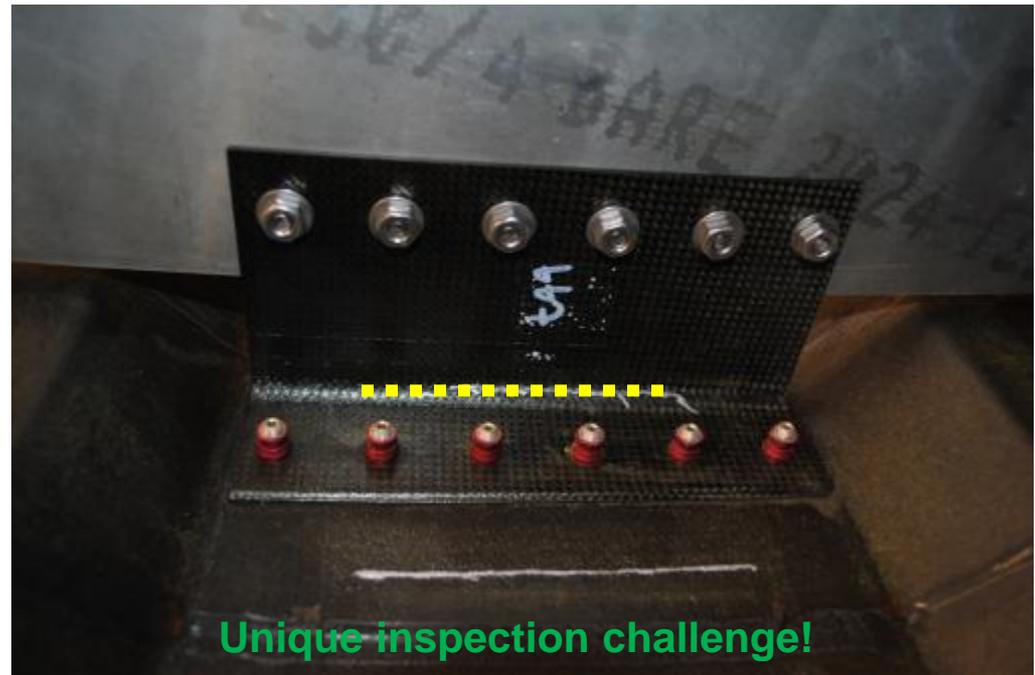
All shear tie impacts cracked the impacted shear tie

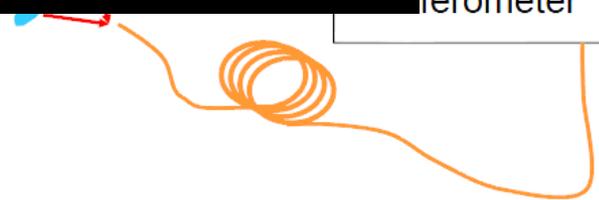
Significant Damage with No Visual Indication

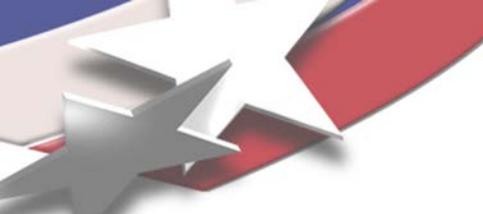
Sponsors and Collaborators
