# Bonded Repair to MD88/90 Horizontal Stabilizer

A4A NDT Forum September 24<sup>th</sup>, 2014

Alex Melton  
Product Line Manager  
Delta TechOps - NDT Programs

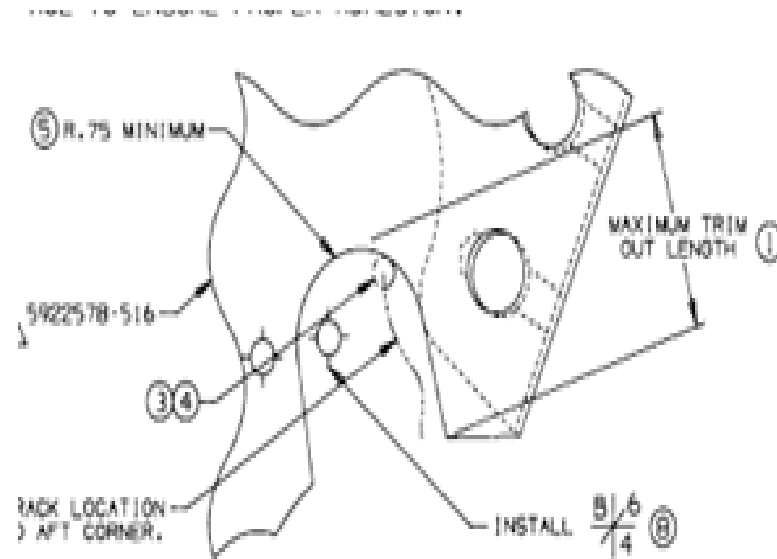
Measure length of stop-drilled crack or trim-out

- Stop drill vs. trim out

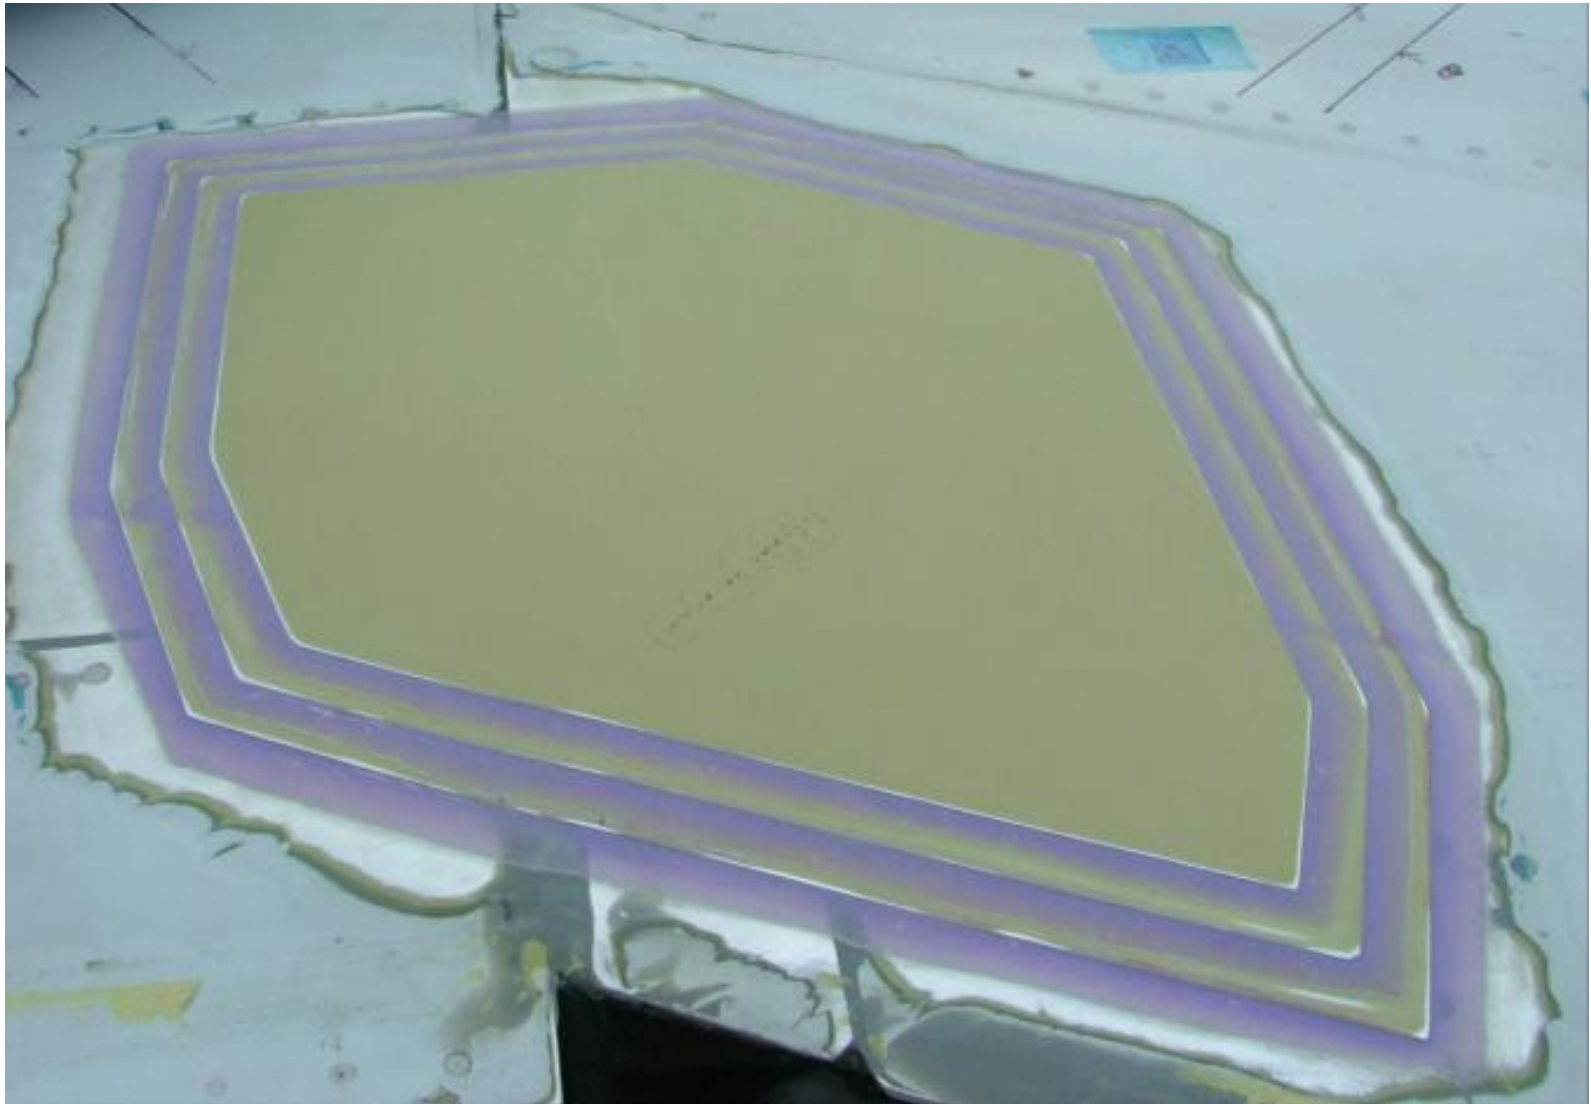
# Installed Repair

- The Bonded repair's on DAL MD88 & MD90 were installed installed per an approved SR Drawing
- AMOC obtained for both MD88 & MD90 repairs
  - AMOC issued on a tail number specific case-by-case basis
- Bonded Doubler can be installed in 3-4 days without removing the horizontal stabilizer
  - As additional installations take place we believe installation time can be cut to 1-2 day's
- Aircraft downtime could potentially be reduced by an average of 10 days versus wholesale panel / spar cap replacement
- Kit and man hour costs offer savings potential
- Repair kits made available by Boeing

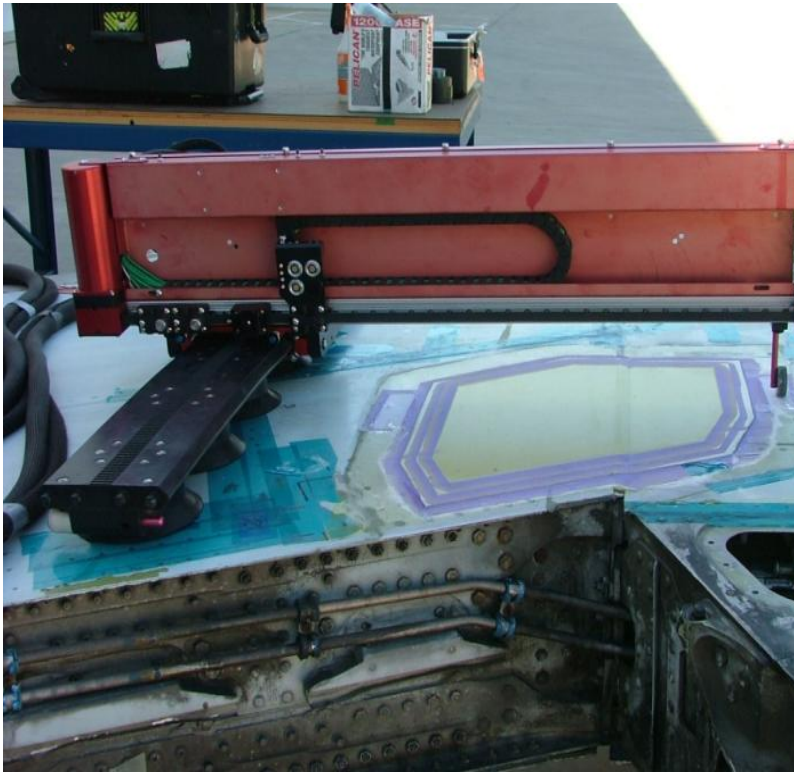
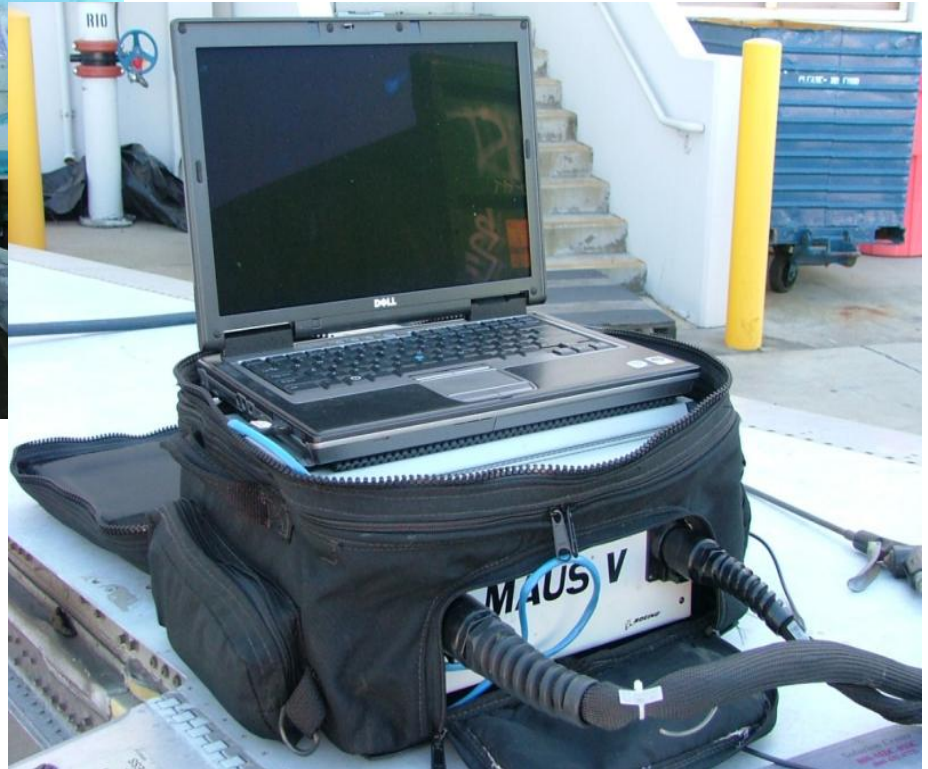
**MAUS V system shown.  
Resonance C-scan for  
unbond detection and Low  
Frequency Eddy Current  
C-Scan for crack detection.**

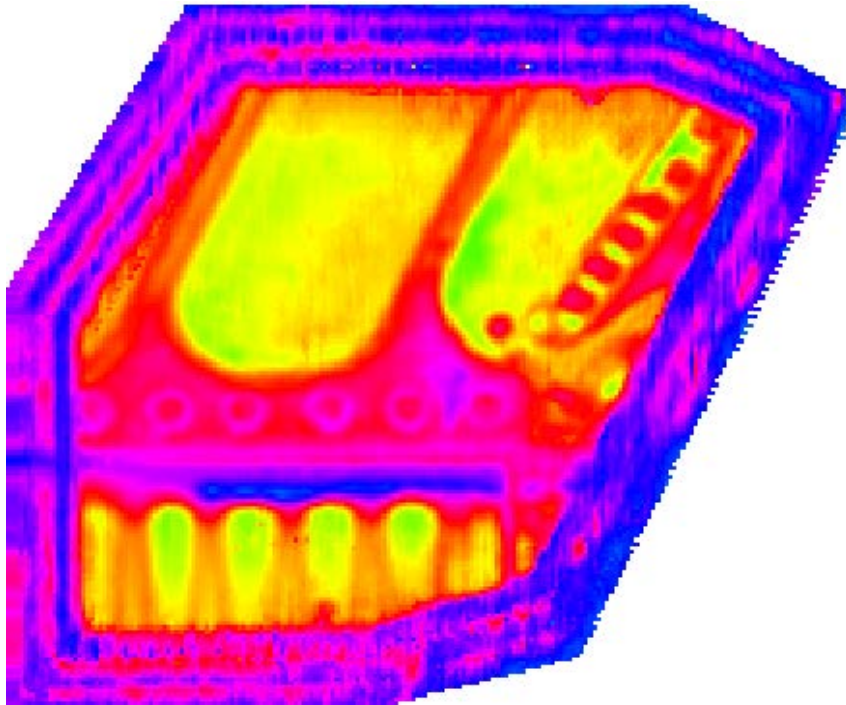
**MAUS Resonance C-Scan Data  
Right Side Repair – 110 KHz  
X Data**

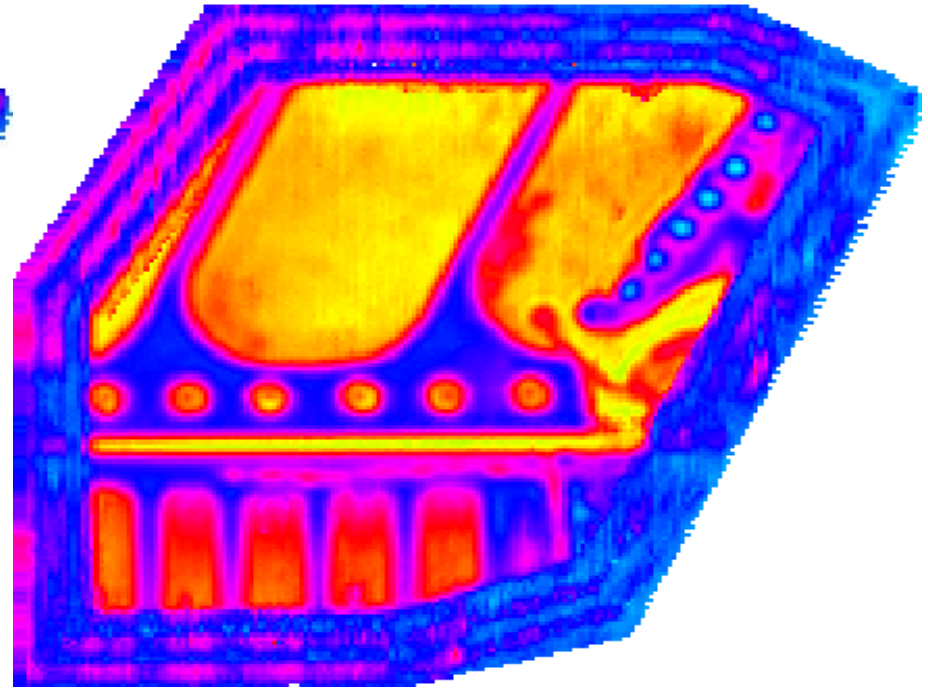
**MAUS Resonance C-Scan Data  
Right Side Repair – 110 KHz  
Y Data**

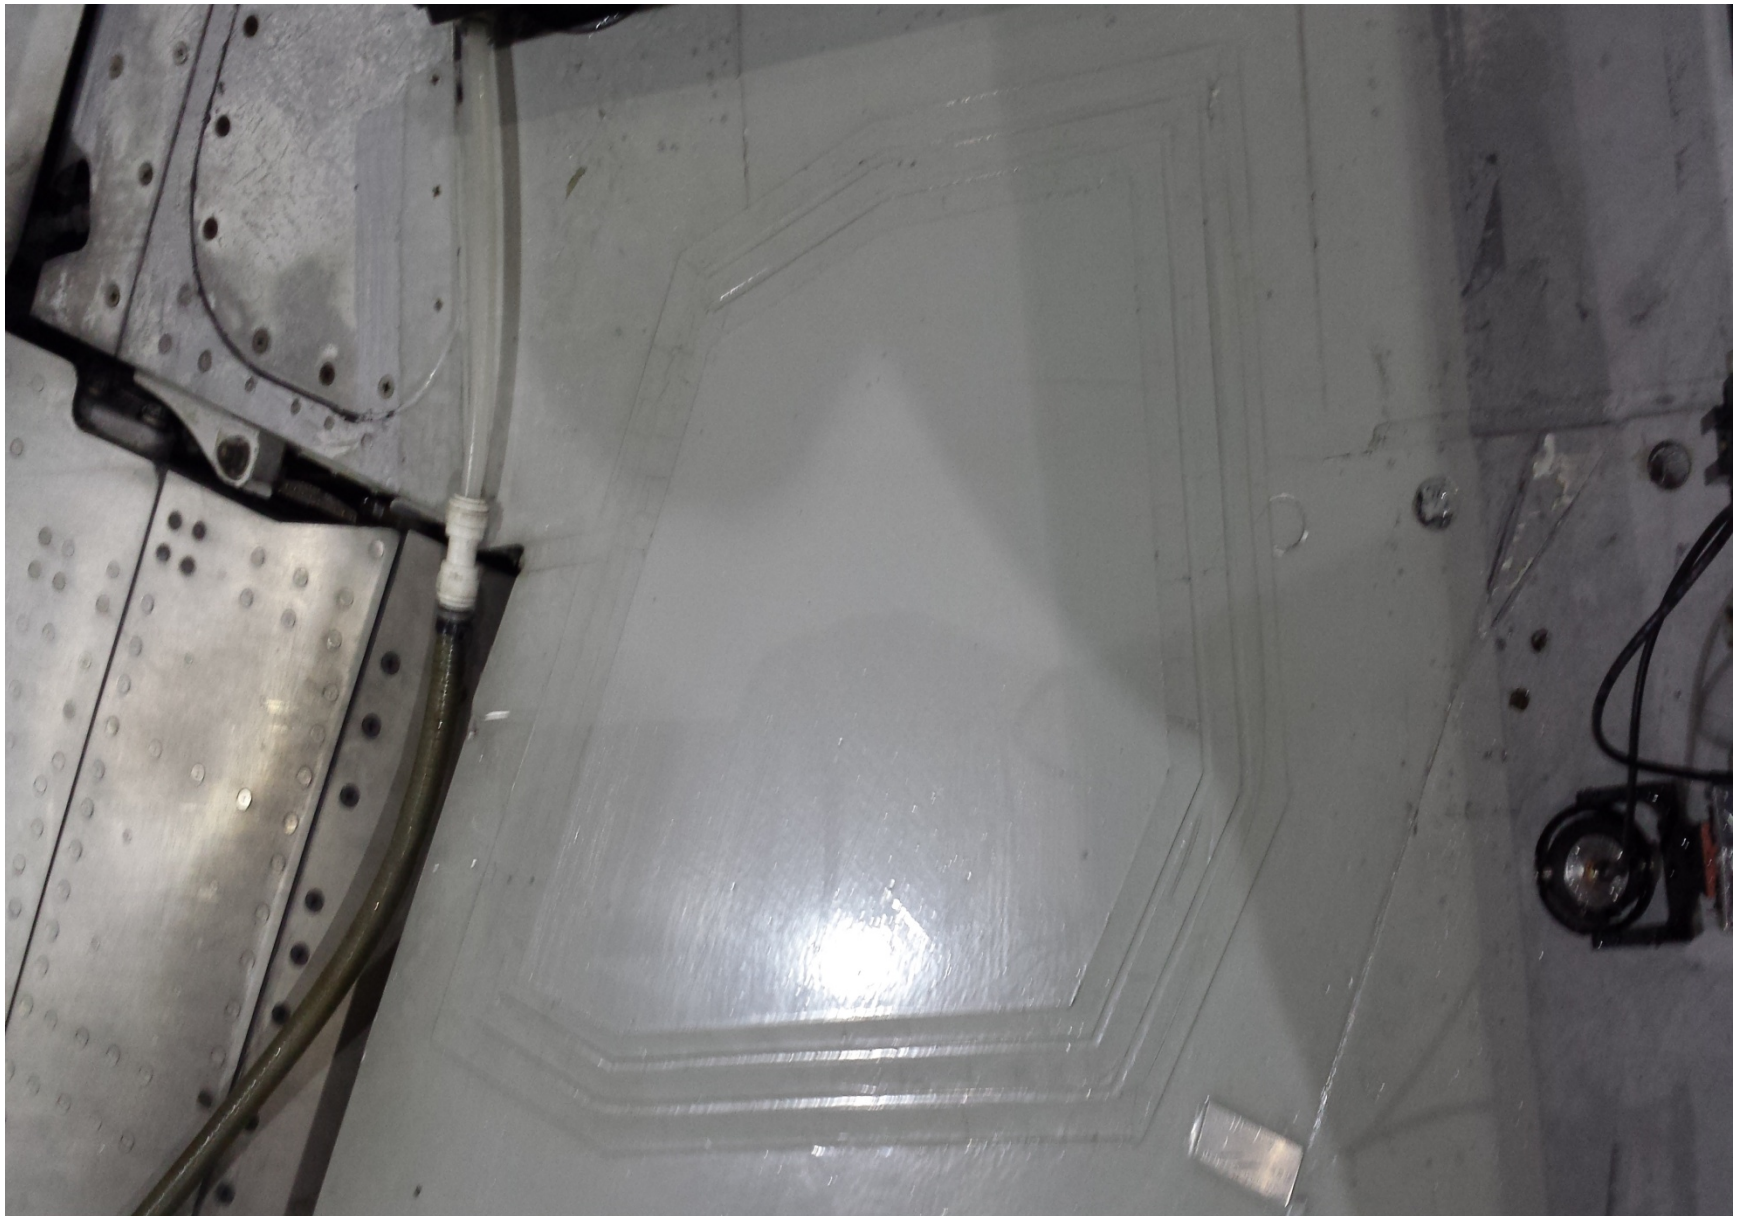
# Repair at 4000 Cycle Resonance Repetitive

- Two installations since 2012: One MD88 / One MD90
- Tail Specific AMOC has been obtained for both installations
- Multiple Eddy Current Repetitive (MAUS V & Conventional) performed on both aircraft with no findings
- MD88 installation repeat Resonance completed with no findings.
  - No further resonance inspections required – scan's submitted to Boeing
  - Eddy Current repetitive inspections continue
- MD90 installation Resonance inspection likely to be scheduled late 2015
- Additional installations being considered by DAL Fleet Engineering
