Supplemental Type Certificate NDT Inspections: Successes and Challenges

A4A NDT Forum, Tuesday, September 23rd, 2014

Alex Melton
Product Line Manager
Delta TechOps - NDT Programs

Example

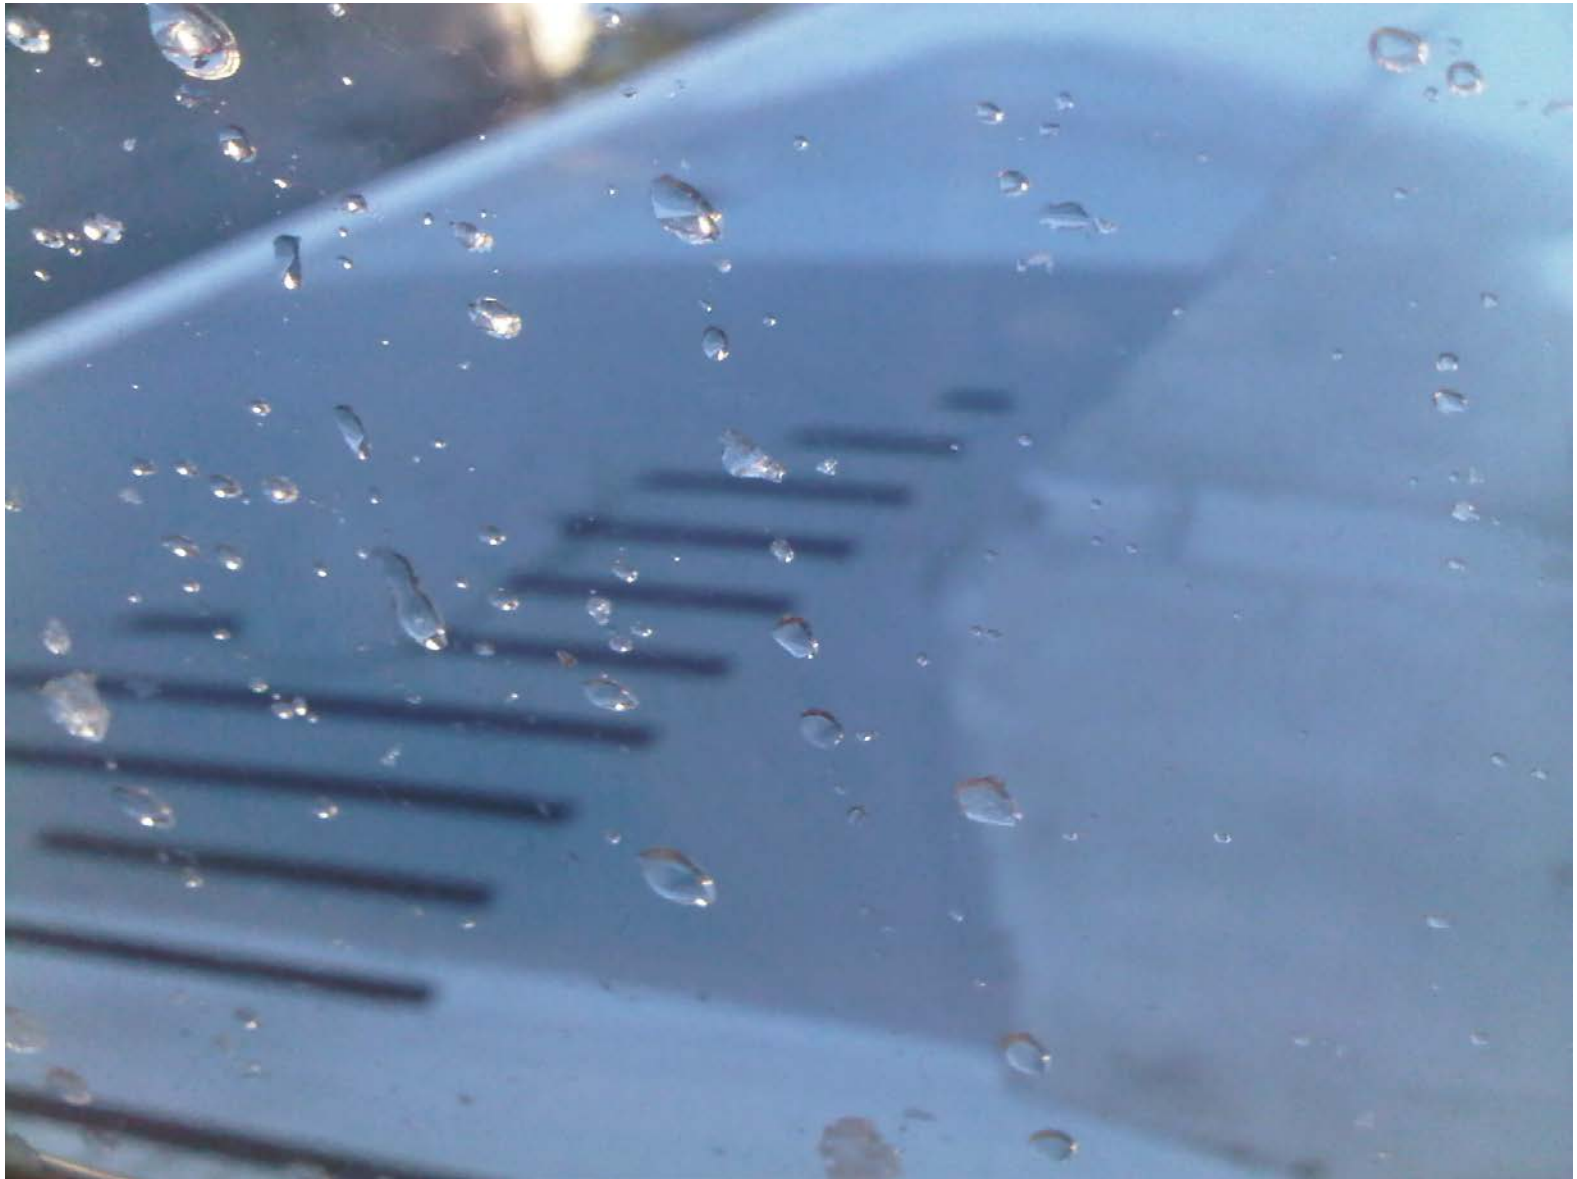
Heater Blanket in operation

- Heater Blanket is mechanically fastened at leading and trailing edges and adhesively bonded. Adhesive (1422-B2) also serves to provide environmental protection.

- The term blanket is actually a bit of a misnomer in that the “blanket” is really more of a honeycomb sandwich sheet with aluminum face sheets and bullnose perimeter. The heating elements are interwoven into the honeycomb sandwich.

- The heater blanket must conform to the upper wing surface geometry. This is typically accomplished by applying adhesive to both surfaces, vacuum, and ballast bags

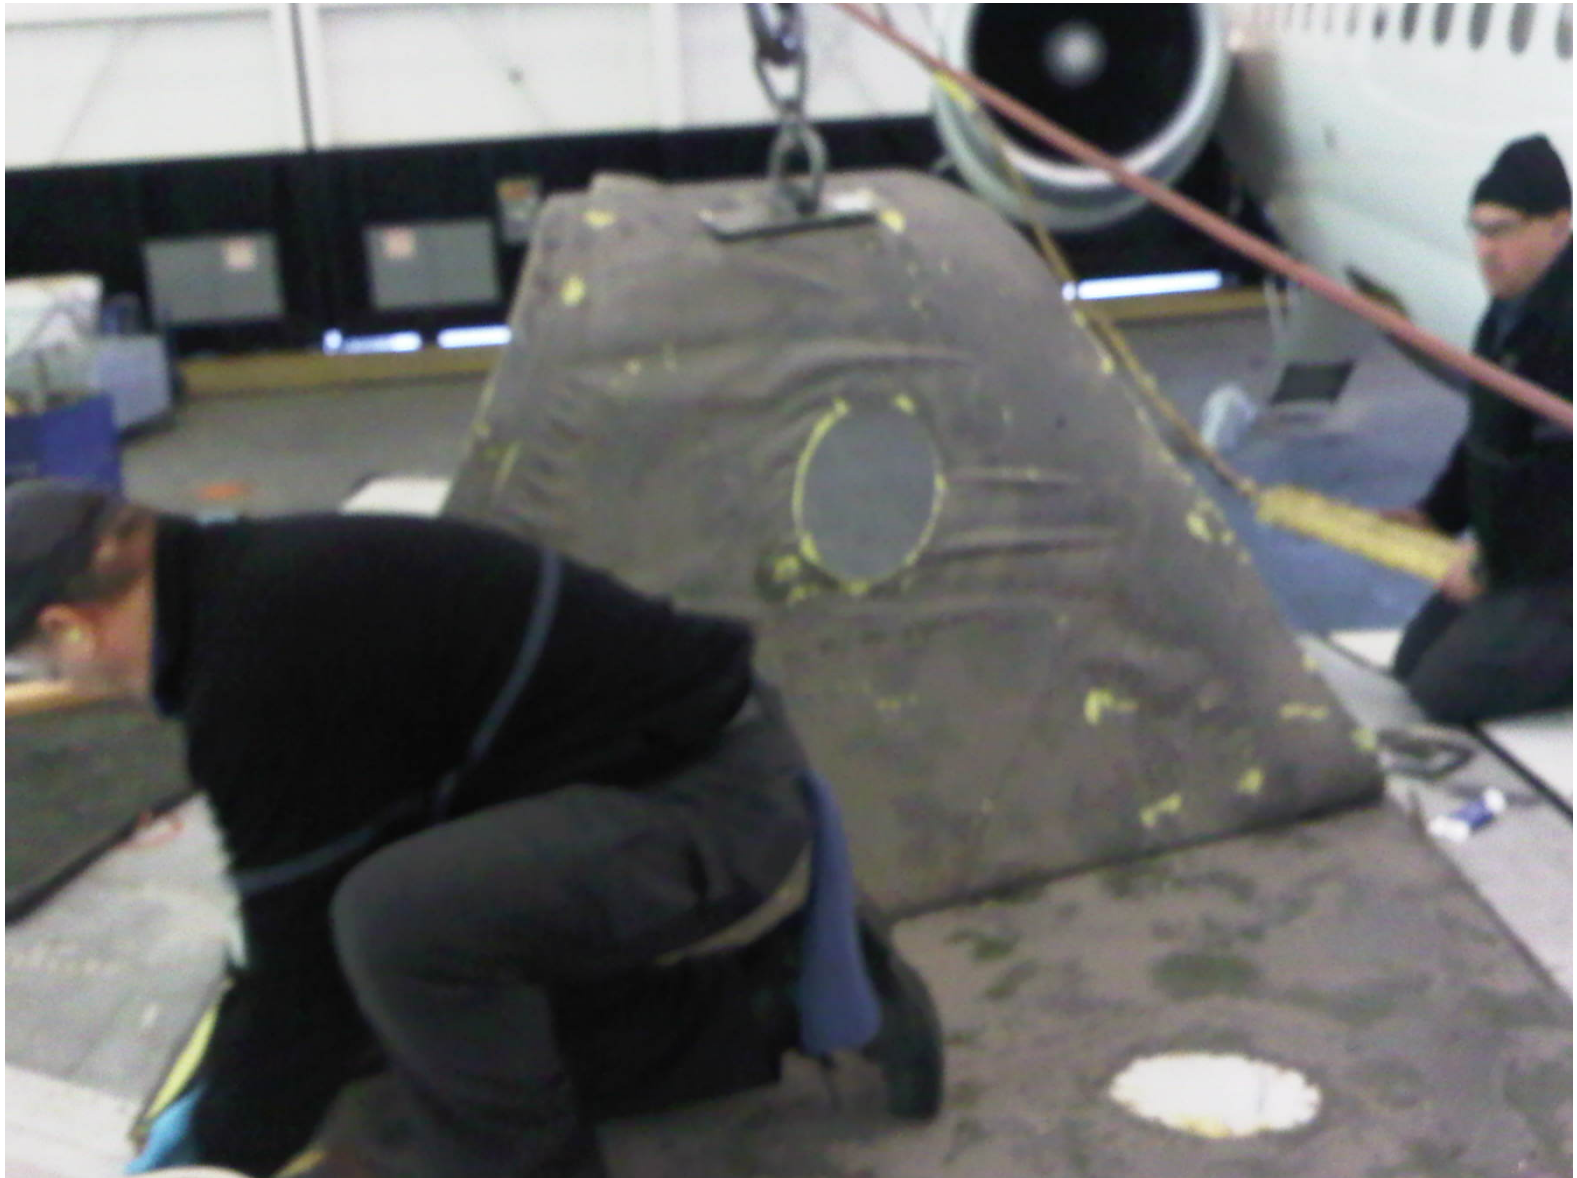
Heater Blanket Removal

- The bond tester and MAUS V indicated that standard is only disbonded in the red lines in the bottom indication, the rest of these showed a combination of bonding and porosity in the sealant.
- From removed heater blankets we have seen porosity in the sealant is fairly common.
- If a blanket fails for body area disbonding from the wing, the blanket is destroyed during the removal process.

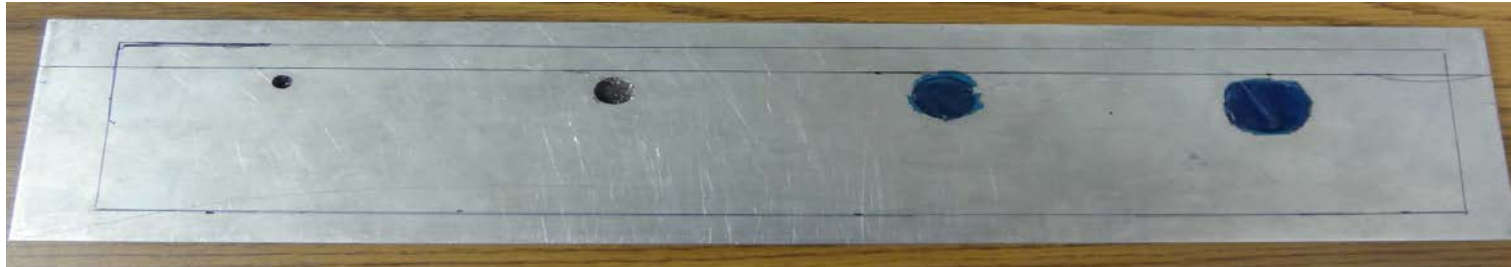
Edge Reference Standard, fig. 1

1/2" wide Inspection/calibration area

- Accomplishing resonance inspection on a curve / tapered edge looking for disbonds in the acoustically attentive 1422-B2 adhesive often yielded inconsistent results.
- Challenges along the edge:
 - Maintaining adequate coupling of the resonance probe
 - Attenuation of sound from rubberized sealant and inspection area geometry
 - Probe rock due tapered curve surface
 - **Flaws not in inspection area for calibration**

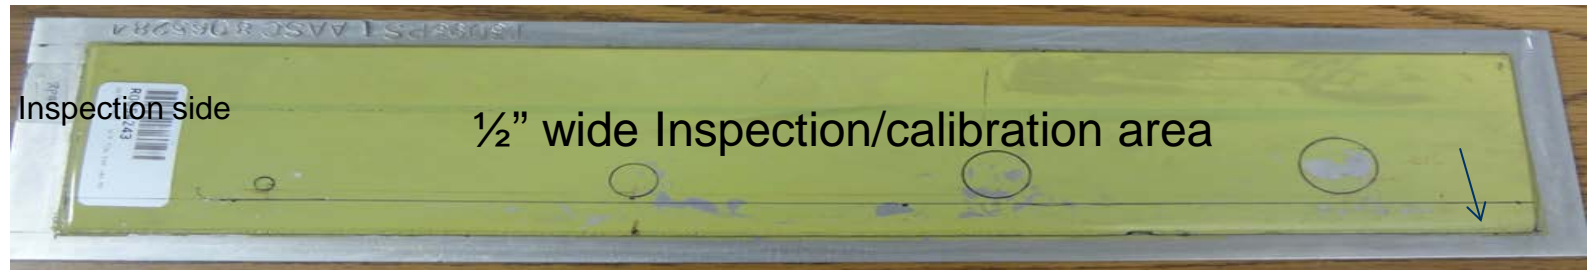
Bottom of standard from STC holder shown/ calibration done from other side

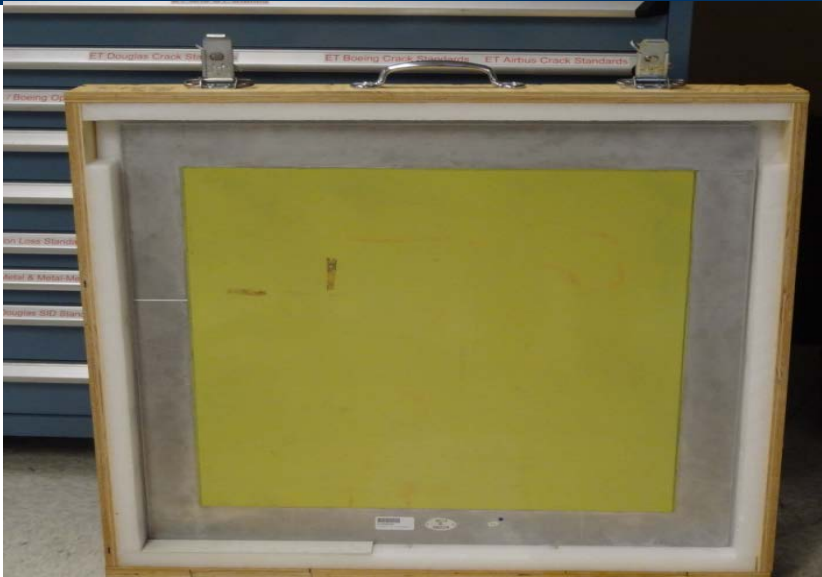
Body Standard, Fig. 2

Honeycomb sandwich bonded to aluminum backing - calibration standard for body area bond test inspection

- Bond test calibration is generic in nature.
- Challenges:
 - Size and weight of standard make it difficult for shipping. Current standard size is 3' X 3' and weighs 70lbs in shipping container. Shipping container is 40" X 40".
 - Most MRO providers not willing to purchase standard due to cost (\$44,000.00).
 - Calibration procedure doesn't differentiate between porosity and disbonding
 - Calibration procedure does not recognize new bond test equipment
