# Bonded Repair to MD88/90 Horizontal Stabilizer

A4A NDT Forum September 24<sup>th</sup>, 2014

Alex Melton  
Product Line Manager  
Delta TechOps - NDT Programs

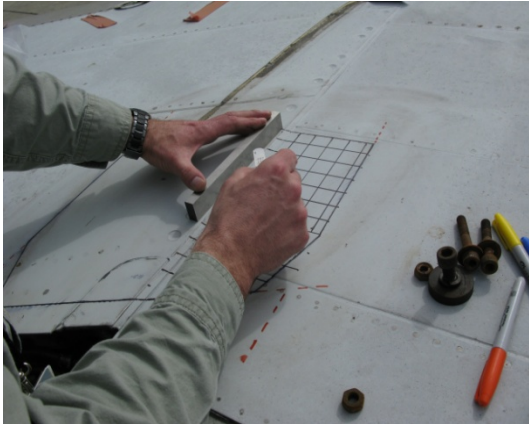
Step 1: Grid out doubler profile using 1 inch x 1 inch squares.

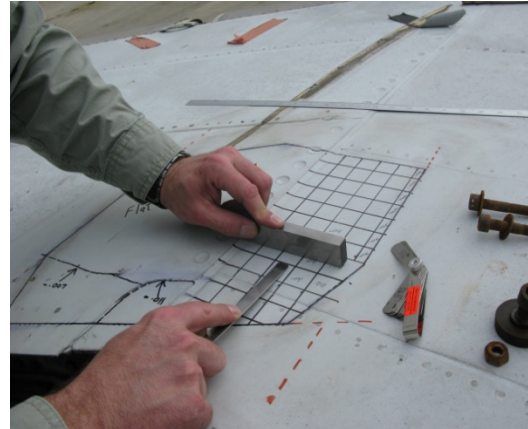
Step 2: Use a straight edge and feeler gage to measure the gaps between the outer aft panel and center panel. Ensure straight edge sits flat on the outer aft panel in the 'flat area'

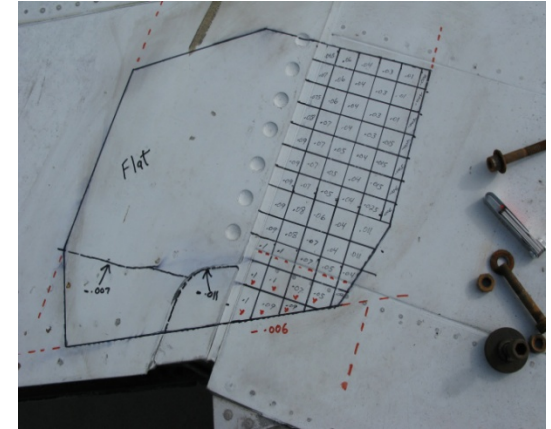
Step 3: Record gap measurements for each grid location. Gap measurements to be taken at the center of each grid. Submit gap measurements with airplane information (Model, fuselage number, serial number and registry).

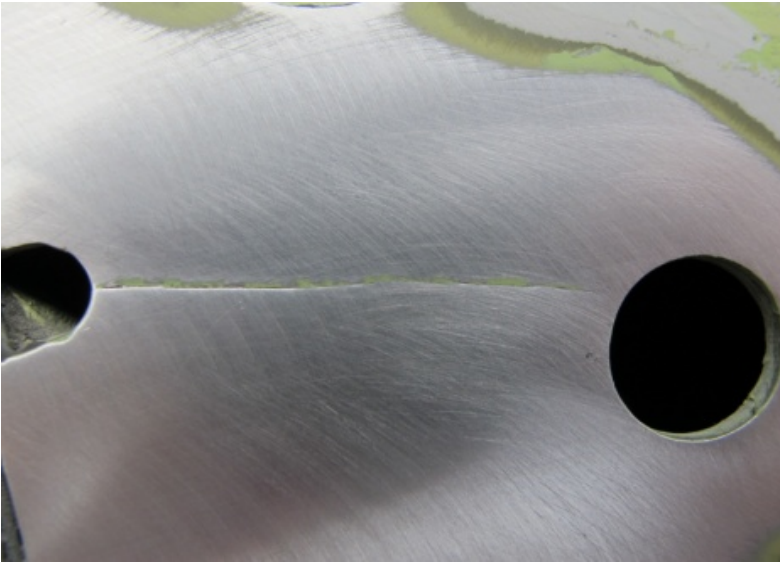
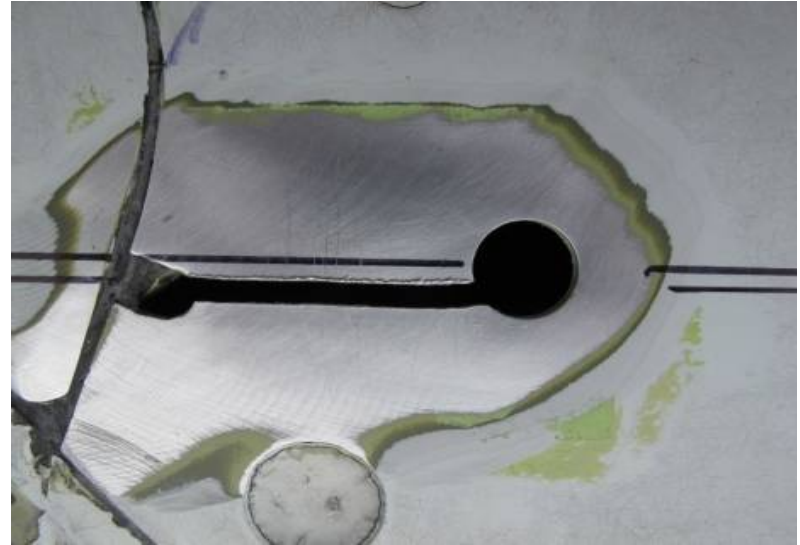
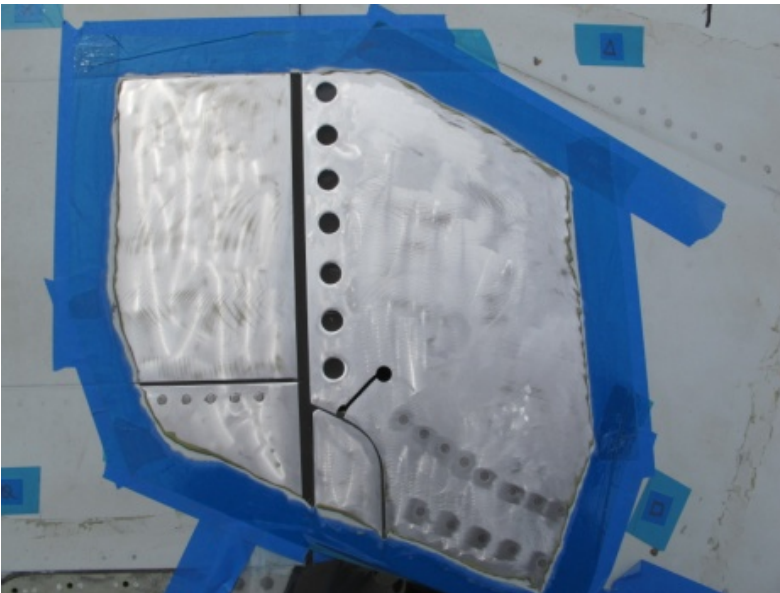
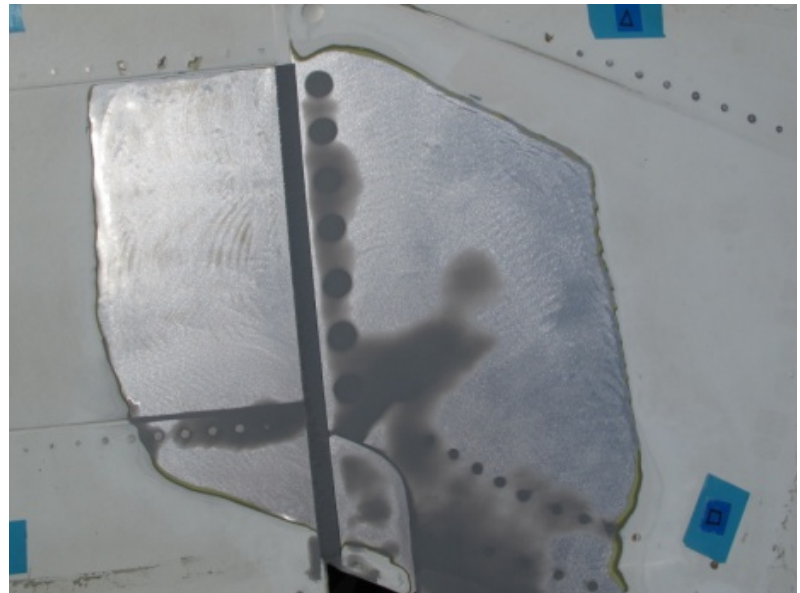
# Damage Containment continued

Measure length of stop-drilled crack or trim-out
